**RE: Bridgewater Town Hall
50 Central Square Bridgewater, MA
Structural Evaluation and Due Diligence**

**BRIDGEWATER TOWN HALL MASTERPLAN / FEASIBILITY STUDY,
Central Square, Bridgewater, MA**

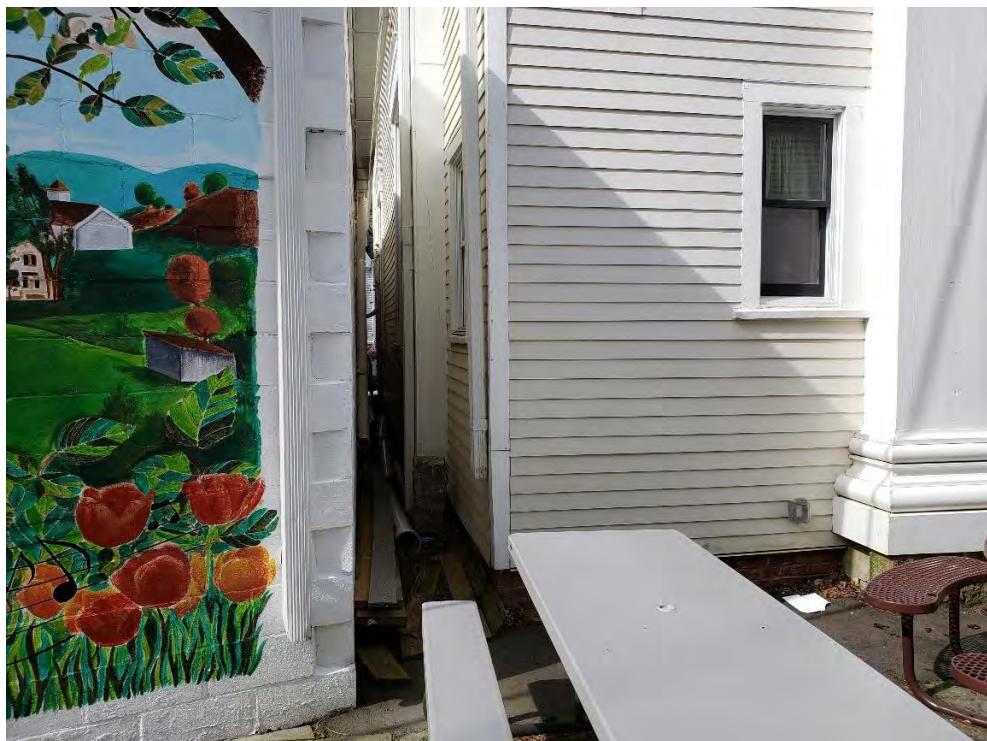
The north, south and rear sides of the town hall building are clad with painted narrow clapboard siding, accented at the four corners of the main building with smooth wood faux corner pilasters. The front façade is finished with shiplap boarding, accented with additional more ornately carved pilasters framing the front entry. The clapboard cladding, shiplap boarding, and painted wood pilasters all appear to be in good, and well maintained, condition. The narrow space between the rear wall of the town hall addition and the adjacent fire department station makes maintenance of exterior both walls very difficult.

Photo 6: Condition of Clapboard and Shiplap Cladding and Pilasters
