**RE: Bridgewater Town Hall
50 Central Square Bridgewater, MA
Structural Evaluation and Due Diligence**

**BRIDGEWATER TOWN HALL MASTERPLAN / FEASIBILITY STUDY,
Central Square, Bridgewater, MA**

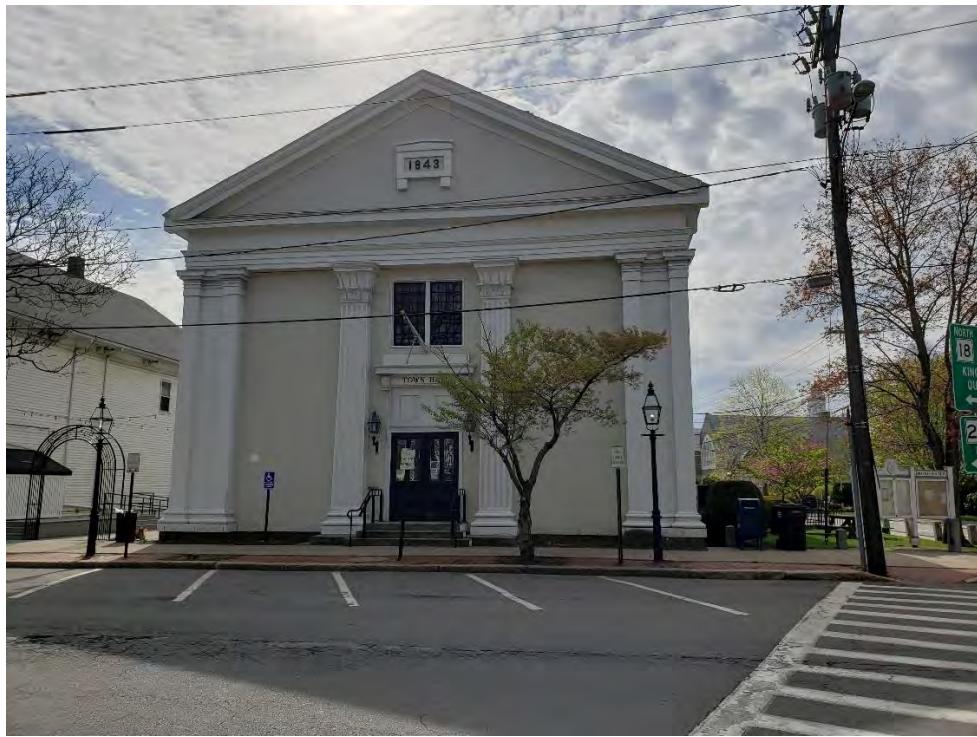
Photo 1: Front (West) Elevation of the Former Bridgewater Town Hall Building

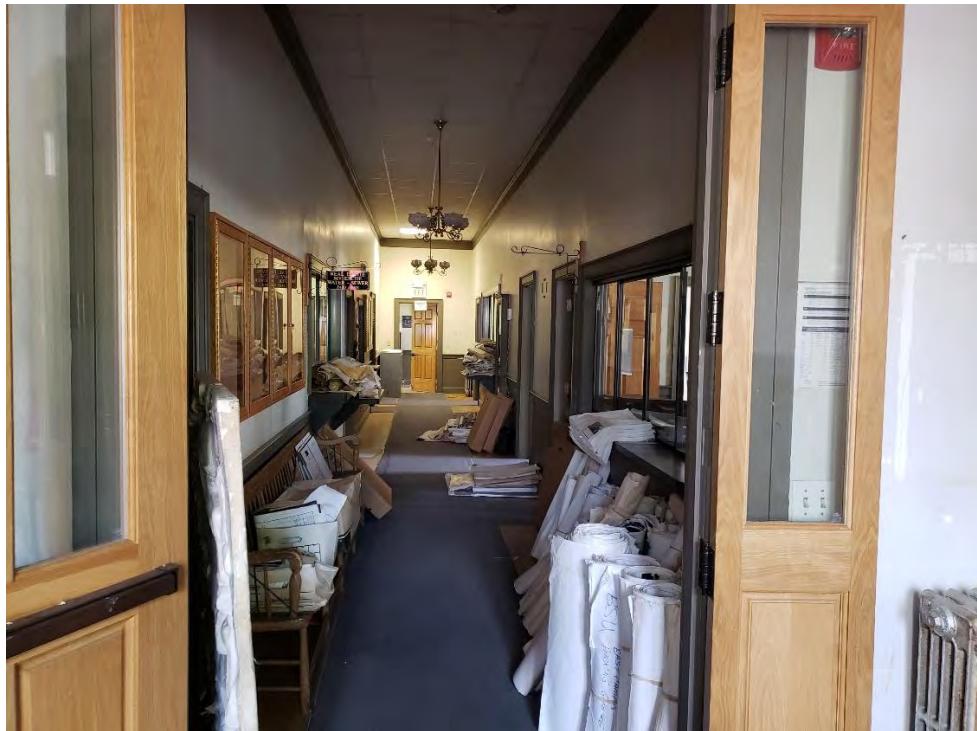
Photo 2: Central Corridor of Main (First) Level

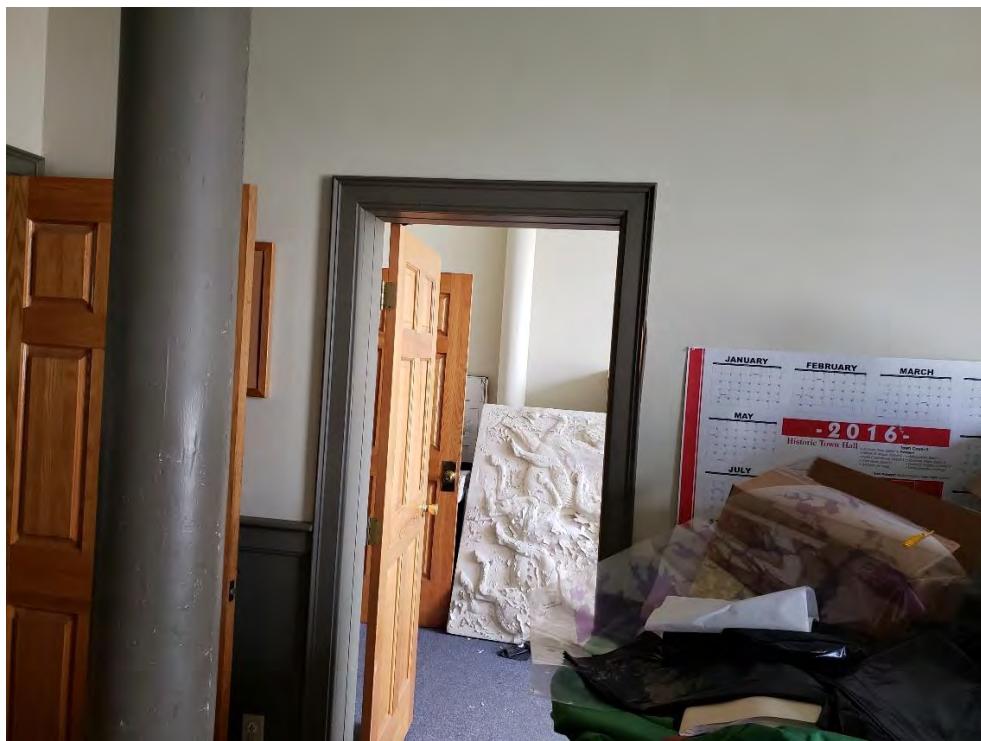
The second-floor level of the central, main section of the floor plate is column-free and was reportedly the large column-free space where town meetings took place. Currently, the space is divided with non-bearing partitions, apparently for other town-related functions. The first level plaster ceiling conceals the framing of the second floor. However, it is assumed to be similar to the first-floor framing, as 7¾" diameter wood pole columns align with the granite posts in the basement that support timber girders and support the second-floor framing system.

Photo 3: Round Wood Pole Columns Supporting Second Floor Framing

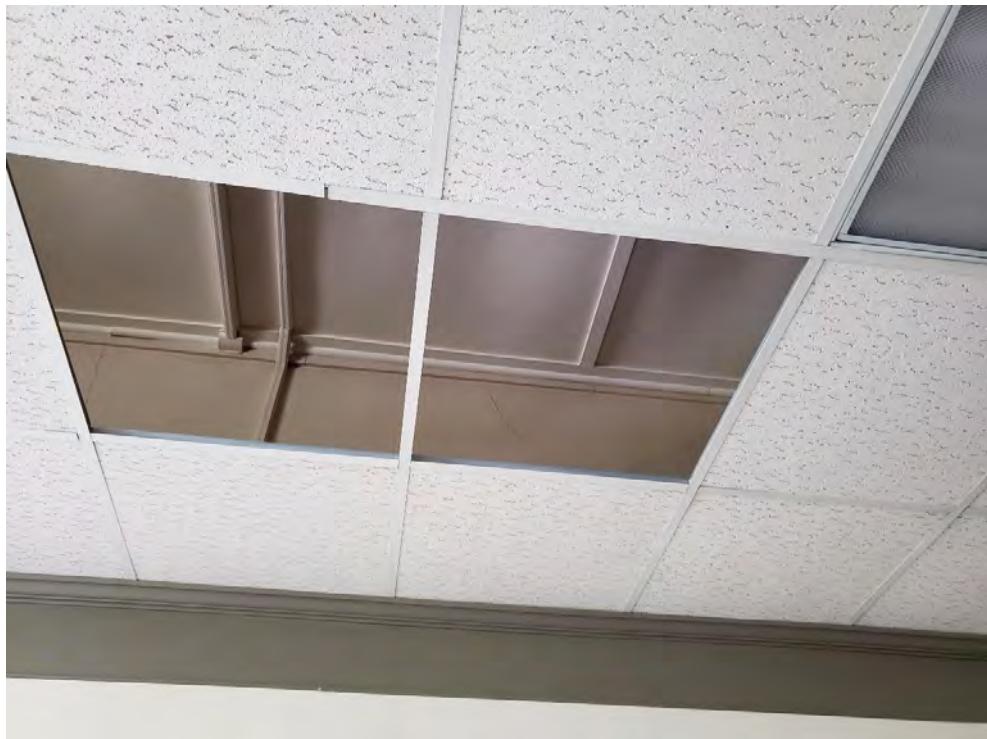
Plaster wall and ceiling finishes appear to be original 19th century three-coat plaster on furred wood lath. Plaster walls, above more modern hung acoustical ceilings, exhibit random cracking. Below the acoustical ceilings, random wall cracks appear to have been patched and repainted. The plaster ceilings above the first floor and applied to the second-floor framing, as observed in areas where the hung ceiling has been partially removed, also appear to be three-coat plaster on furred wood lath. However, it appears that the original plaster had become cracked and loose, requiring reinforcing consisting of either homasote panels or gypsum wallboard panels with wood batten strips fastened through the failing plaster to either the wood lath or the second-floor framing. The plaster ceilings above the second-floor plaster and applied to the attic framing appears to be original 19th century three-coat plaster on furred wood lath. These plaster ceilings are in poor condition, with several areas patched with applied gypsum board and other unrepaired areas of missing plaster and exposed wood lath above hung acoustical ceilings. With the amount of reinforcing that was added to the original timber attic/roof trusses, it is likely that the original roof trusses had deflected, exacerbating the damage to the plaster ceiling that relied on these trusses for support. It is likely that, most of the original 175-year-old three-coat plaster on furred wood lath wall and ceiling finishes has lost its key with the wood lath and is a future potential hazard. As part of any future adaptive reuse of the Town Hall building, it is likely that wall and ceiling finishes will be removed and replaced.

Photo 8: First Floor Reinforced Ceiling Above Hung Acoustical Ceiling

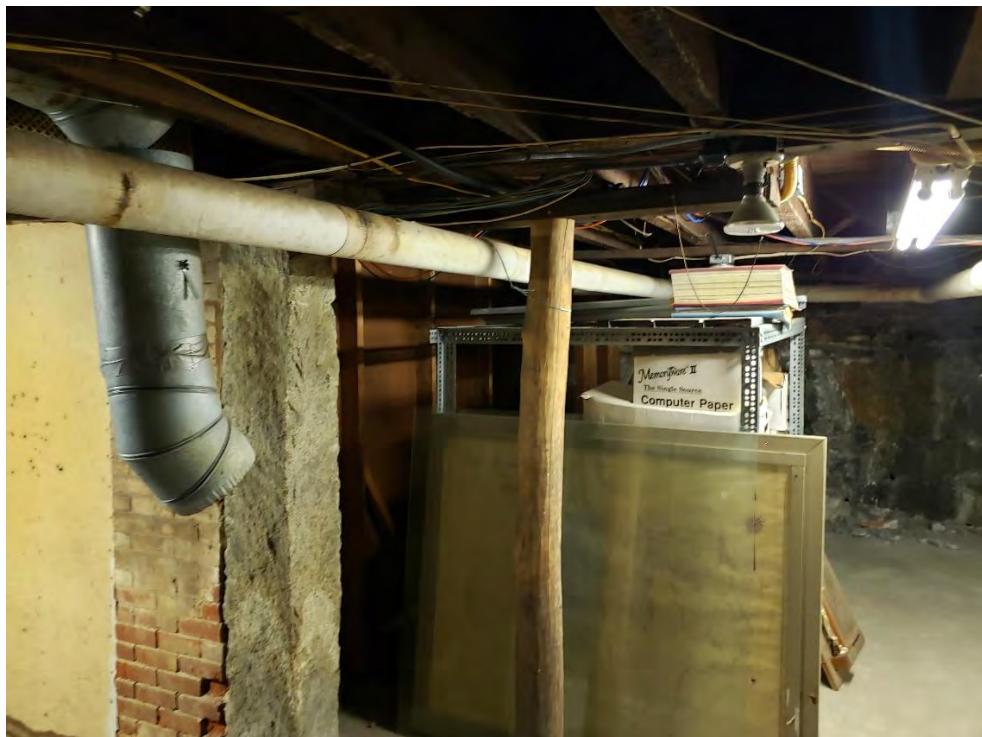
The basement space is low overhead space and the first-floor framing, supported on a system of granite columns, is exposed. The framing is generally in good condition except for a few failed joist-to girder mortised connections that have been locally resupported with additional timber posts. (refer to analysis below). The surrounding basement walls are a combination of granite block, rubble stone and some interior brick. The basement floor is concrete. Again, we observed no sign of foundation settlement.

Photo 10: Basement Granite Columns and Timber Pole Reinforcing Supporting First Floor Framing

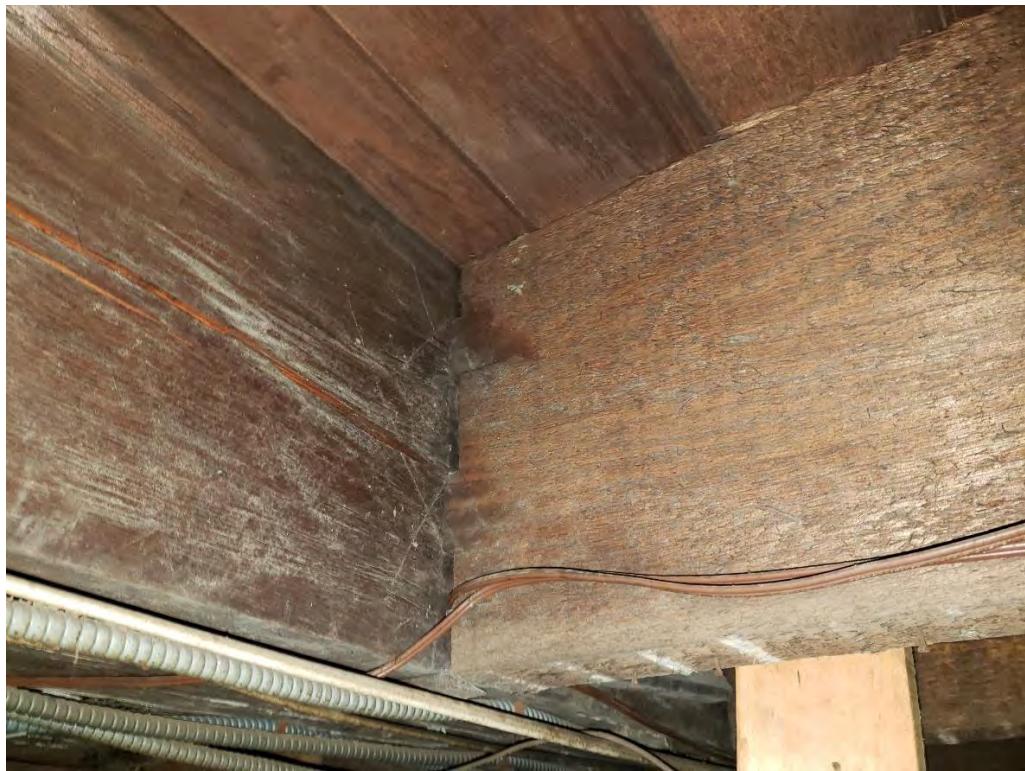
Photo 11: Typical Double Mortise Connection of First Floor Joists to Timber Girders

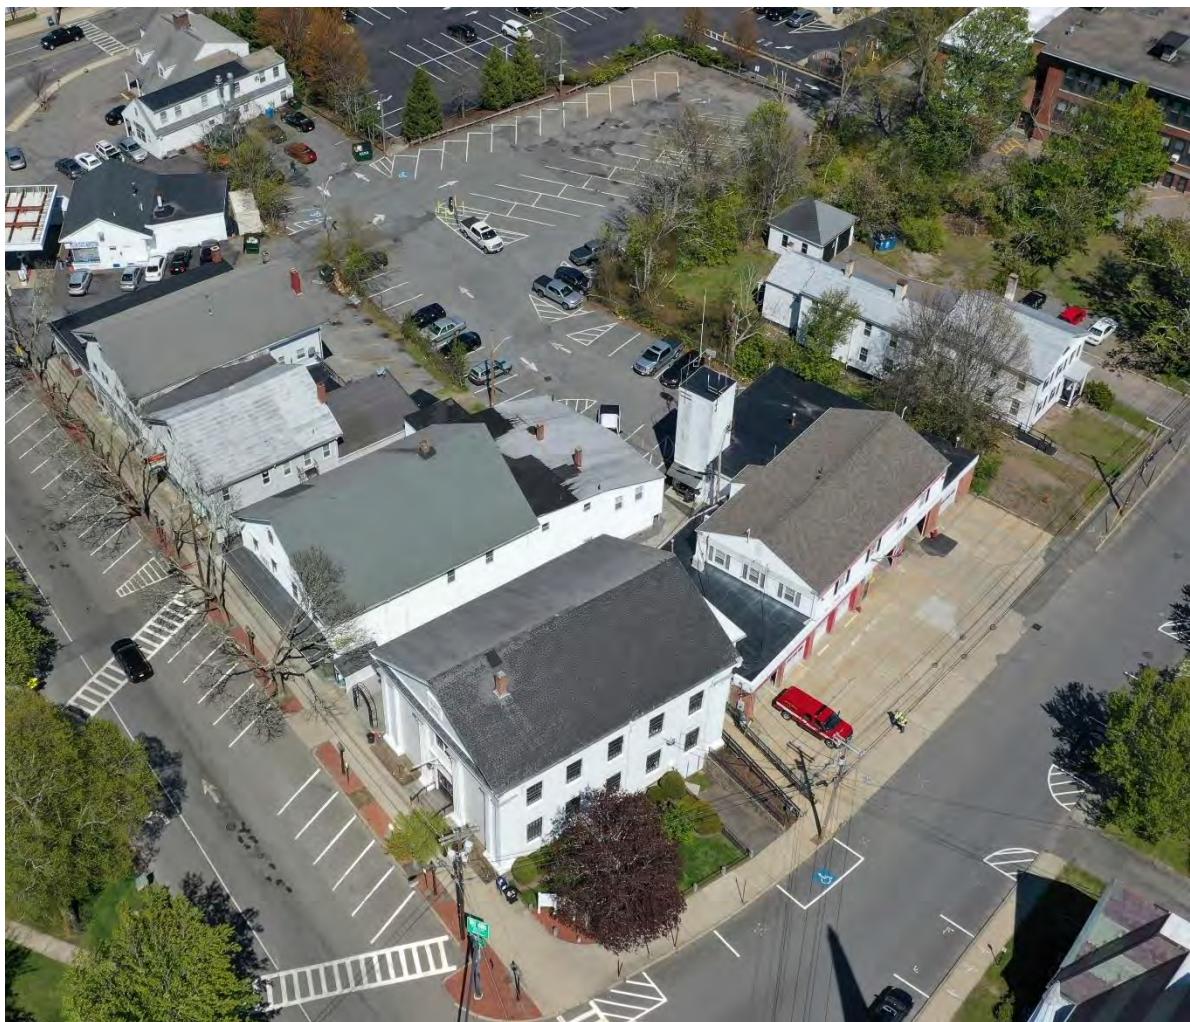
Photo 13: Aerial View of Town Hall and Adjacent Buildings Looking from The East.

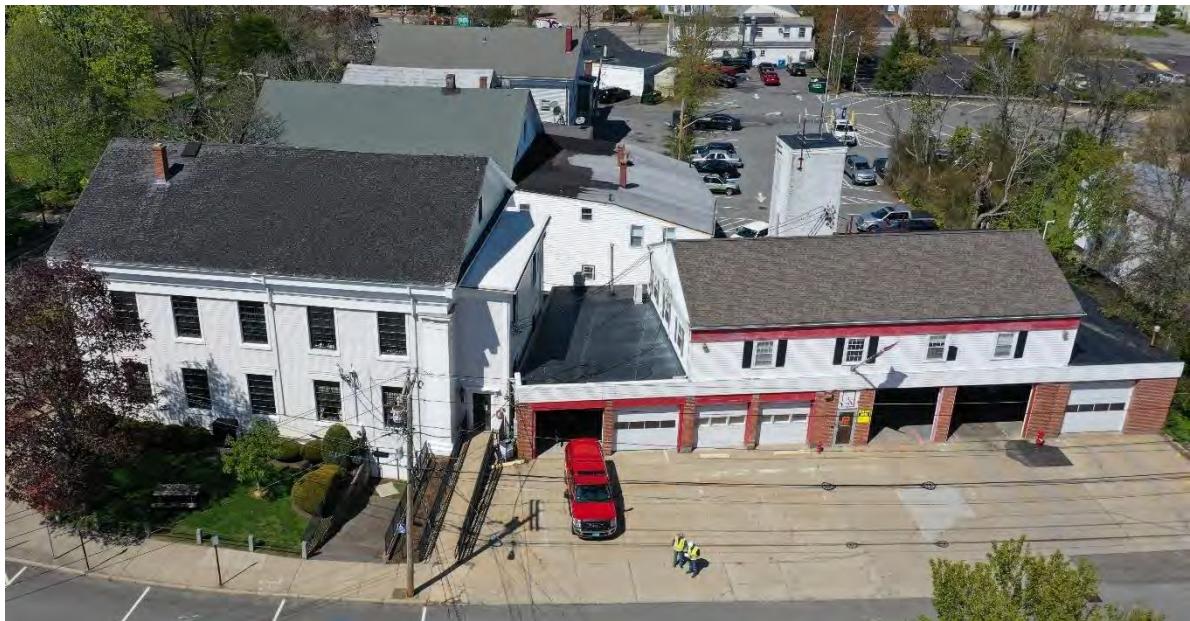
Photo 14: Aerial View of Town Hall and Fire Station Looking from The North-North East.

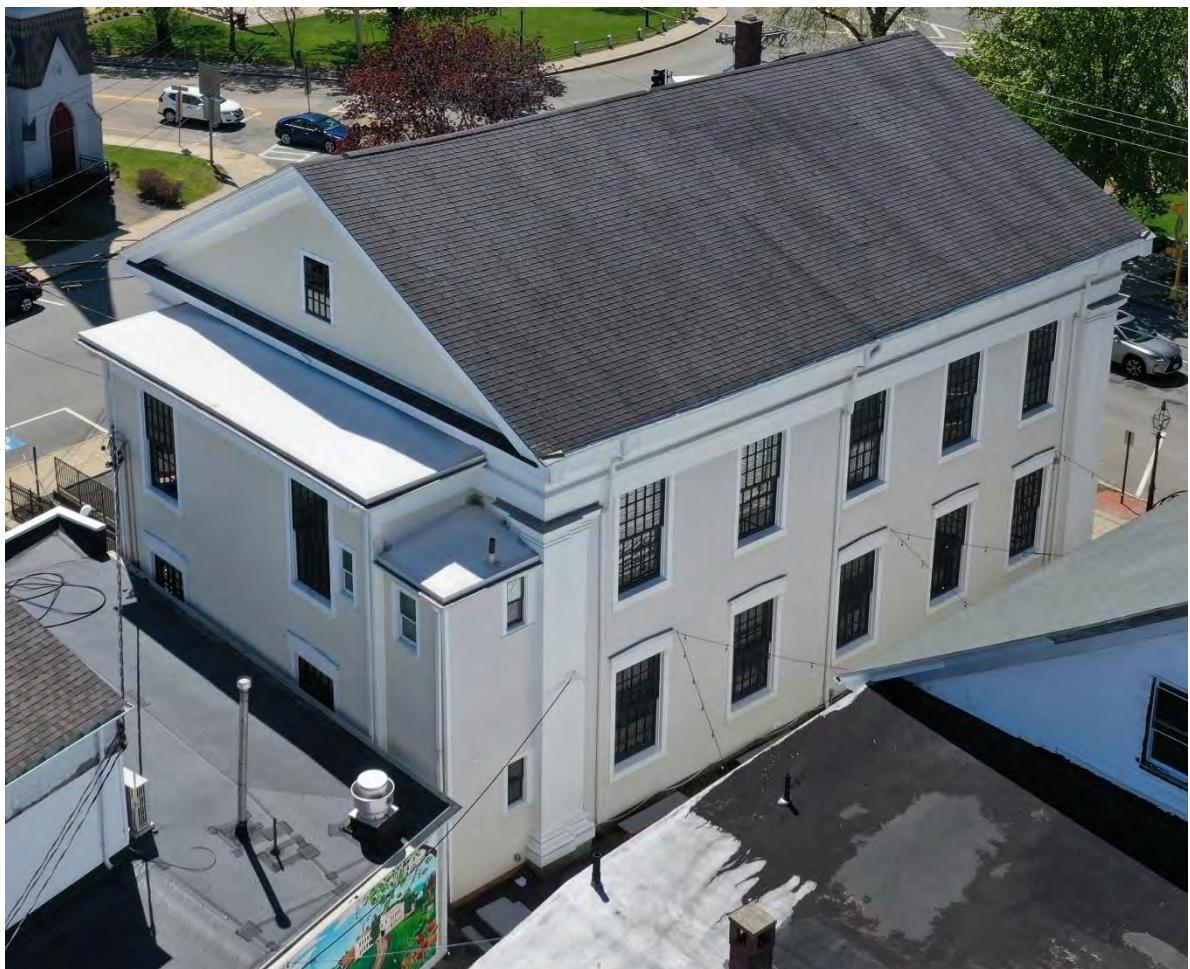
Photo 15: Aerial View of Town Hall Looking from The South West.
